## Right Way Inspections

125 East Line Street  
Geneva , IN  
Phone: 260-267-5027

# Summary

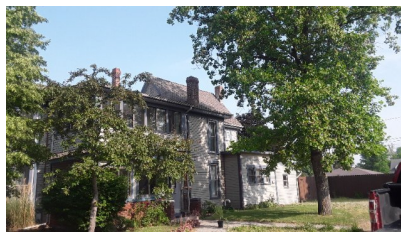
Observed mature trees which could result in damage to the house.

There was shrubs and other growth up against or near the foundation and exterior walls.

green growth can get into the fan of the AC unit.

It is recommended to have 6 feet clearance on any moderately sized rooting systems.

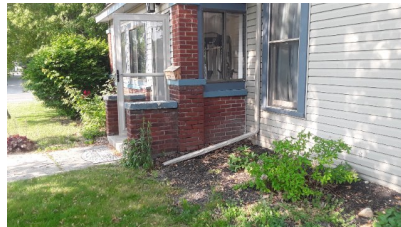
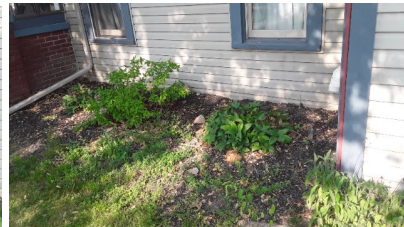
Observed lack of the recommended 9-11 inches clearance from ground to first wooden element of exterior wall.

when mulch is placed in direct contact with siding. This provides a easy access to WDO insects to enter exterior wall.

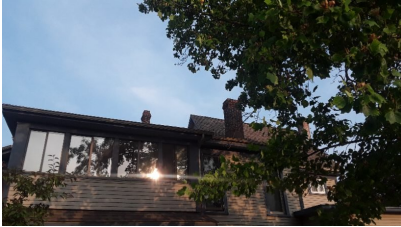
·The chimney is missing a weather-protective cap.

Missing chimney cap

there was birds sitting on the opening of chimney. Can not confirm if there entering or not.

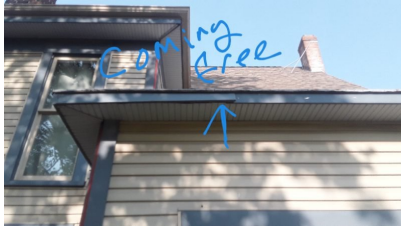
On the side of the house there was one section with metal flashing which looked to be coming free should be really secured

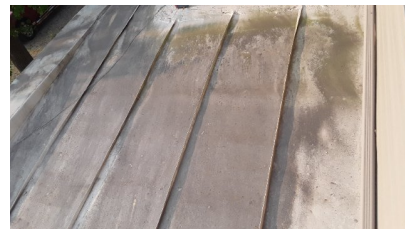
Water staining which indicates water pooling in the area

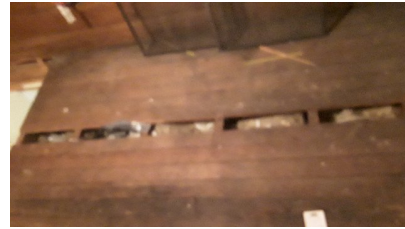
**Comments:**  
There has been large modifications made to the roofing system of this dwelling.  
You can see in the Attic an old roofing system which had wooden shakes placed for roof covering. There has been a new roof structure built over the top of that.  
The old roof structure does remain. There was ceiling coverage in one area of the attic and the other attic had just a small hole where you can visibly see inside of it.

There was not much visible area of roofing rafter system.  
What was visible wasn't functional condition and built over an old system

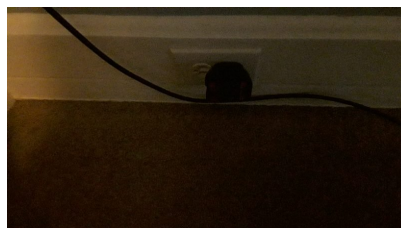
I observed that both windows to be within a few inches of the flooring.  
This is a fall from window risk and does not meet the current a standard of clearance from the floor for safety.  
should be above 24 inches

Noted uneven flooring in this room.

Observed only two visible Outlets. This is below the common day standard of Outlet requirements.  
I observed the outlet which is not currently being used to be dead non-functional using my tester.

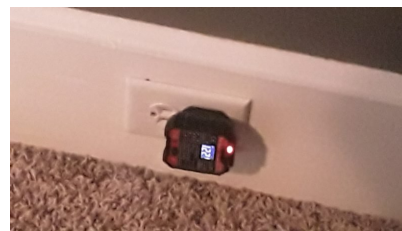
non-grounded 3 prong outlets. Missing cover.

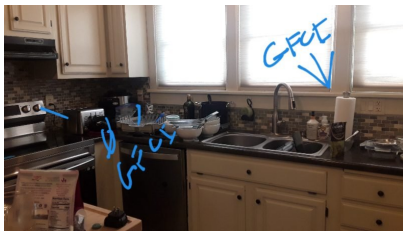
I observed the receptacle which is within one foot of the sink to be GFCI protected.

The receptacles between the range and the sink is recommended to be GFCI protected

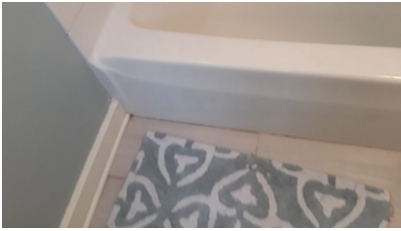
Seal/caulking could be improved at the floor bathtub connection. Minor moisture damage noted at Bathtub wall and drywall connection near the shower head

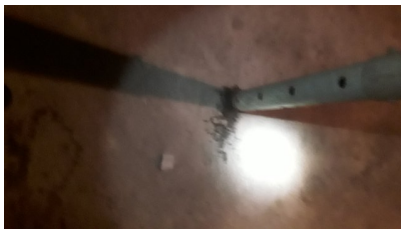
I observed the floor jacks to have heavy rust damage which is compromising the Integrity of the support.

Compromise rest damage to bottom have the steel Jack

It is recommended to contact a licensed structural engineer to recommend proper repairs of the support for the first floor.
